ANNEX III - ENGINEERING SCHEDULE

1 INTRODUCTION

The APPENDIX describes current conservation conditions of existing buildings and public amenities within the CONCESSION AREA.

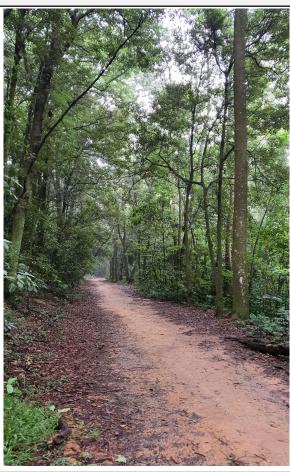
IDENTIFICAÇÃO DA ESTRUTURA						
Elemento:	Área externa					
Parque Núcleo	Parque Estadual Alberto Löfgren Horto Florestal					
Nome:	06 - Trilhas					
Uso atual:

Deverá realizar a manutenção das trilhas e implantar placas informativas.

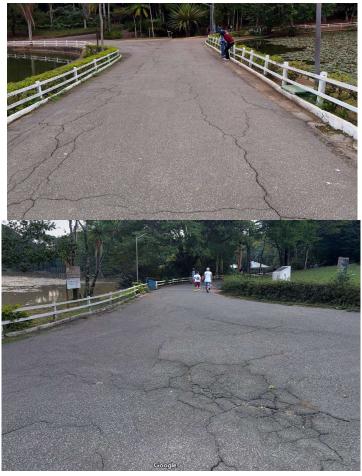
Elemento: Área externa Parque | Núcleo Parque Estadual Alberto Löfgren | Horto Florestal Nome: 41 - Caminhos Uso atual:

Os caminhos do horto são em asfalto e apresentam trincas. É necessário realizar recape nas vias, para manutenção do asfalto. O ideal seria a substituição do piso para material mais sustentável e permeável.

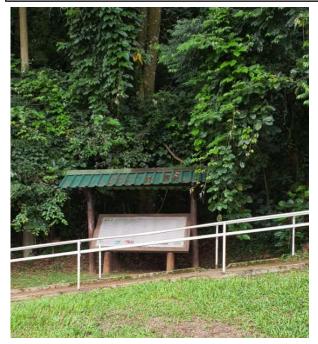
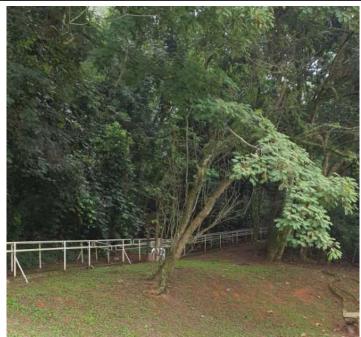
Elemento:	Área externa
Parque Núcleo	Parque Estadual Alberto Löfgren Horto Florestal
Nome:	42 - Trilha do Arboreto 500 anos
Uso atual:	320

Necessário realizar a manutenção e implantação de mais placas informativas.

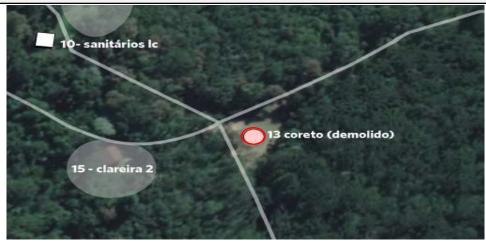
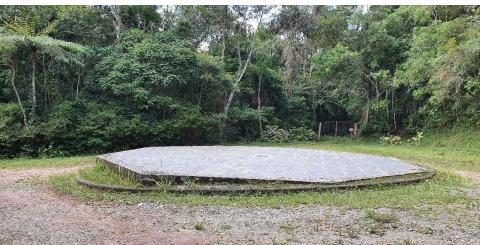
Nome: 13 - Coreto demolido
Uso atual: Contrapiso em concreto

No local havia um coreto que foi demolido.

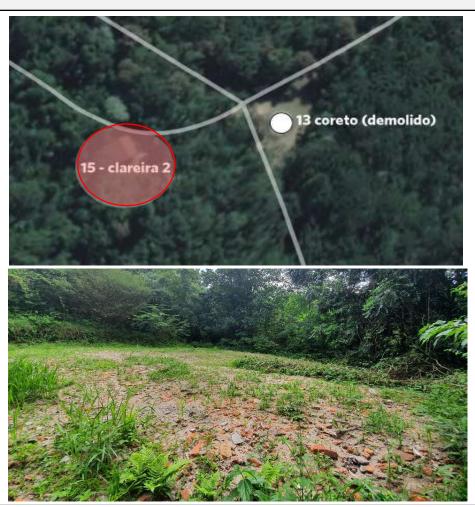
Elemento: Área externa Parque | Núcleo Cantareira | Núcleo Águas Claras - Lago das Carpas Nome: 15 - Clareira 2 Uso atual: 115,00 m²

Nesta clareira havia antiga residência de funcionário que foi demolida a pouco tempo. Local não possui energia elétrica.

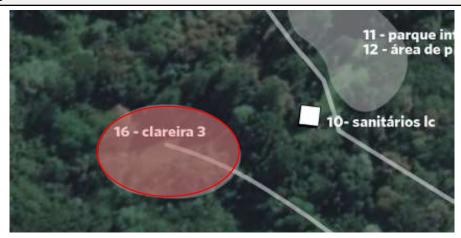
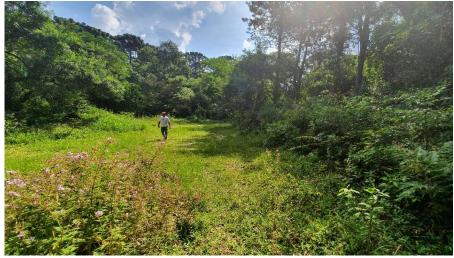
Elemento: Área externa Parque | Núcleo Cantareira | Núcleo Águas Claras - Lago das Carpas Nome: 16 - Clareira 3 Uso atual:

Nesta clareira havia antiga residência de funcionário que foi demolida a pouco tempo. Local não possui energia elétrica.

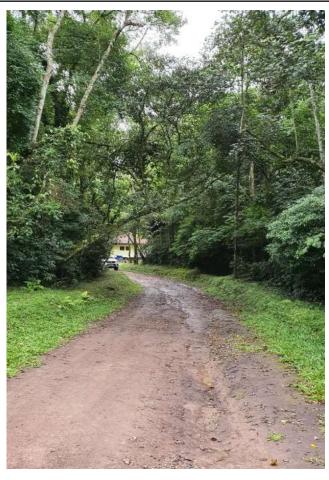
Elemento: Área externa Parque | Núcleo Cantareira | Núcleo Águas Claras Nome: 17 - Trilha do Lago das Carpas Uso atual: 1.324,00 m - Caminhada, fiscalização, conexão de núcleos.

Necessário realizar a manutenção da trilha e implantar placas informativas.

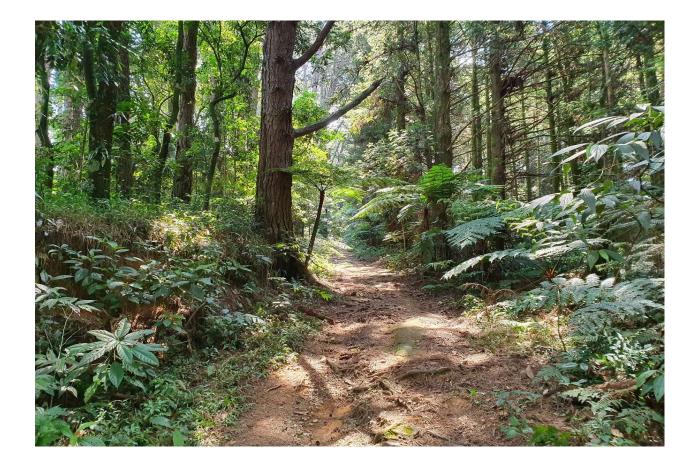
IDENTIFICAÇÃO DA ESTRUTURA				
Elemento:	Área externa			
Parque Núcleo	Cantareira Núcleo Águas Claras			
Nome:	18 - Trilha da Suçuarana			
Uso atual:	1.130,00 m - Caminhadas, fiscalização e conexão dos núcleos.

Necessário realizar a manutenção. Deverá Implantar placas informativas.

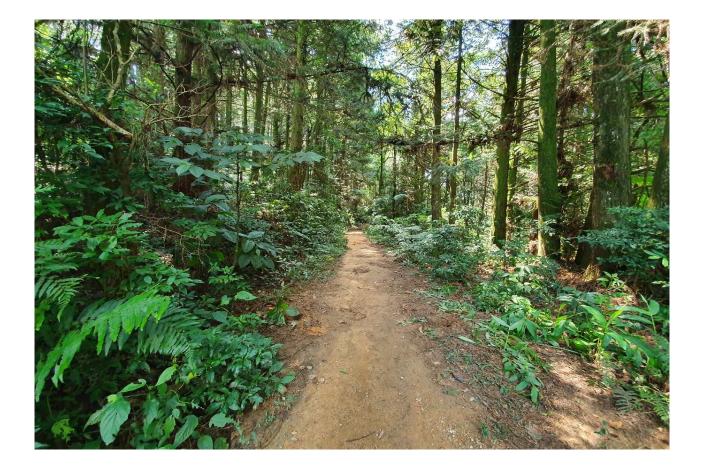
Elemento: Área externa Parque | Núcleo Cantareira | Núcleo Águas Claras Nome: 19 - Trilha da Samambai-açu Uso atual: 1.658,00 m - Caminhadas, fiscalização.

Necessário realizar a manutenção. Deverá Implantar placas informativas.

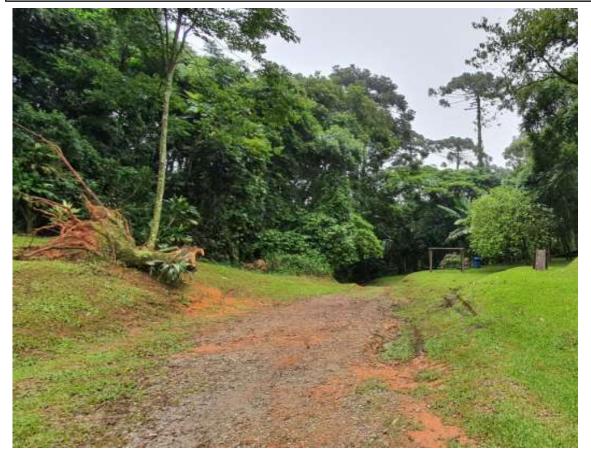
Elemento:	Área externa
Parque Núcleo	Cantareira Núcleo Águas Claras
Nome:	20 - Caminho Portaria Águas Claras
Uso atual:	1.560,00 m

Necessário realizar a manutenção. Deverá Implantar placas informativas.

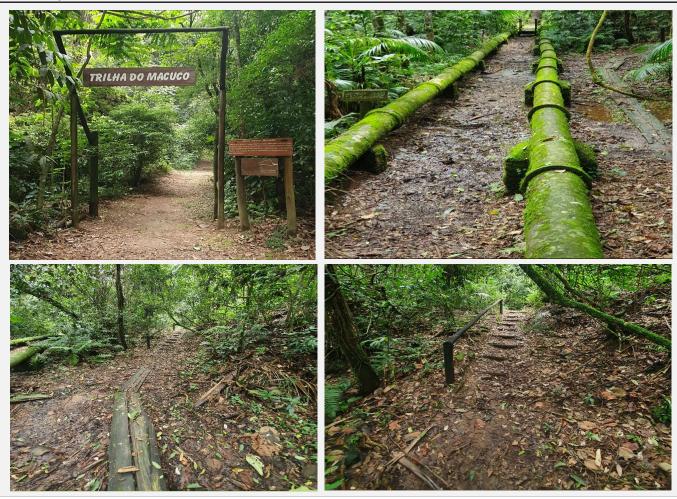
A Trilha do Macuco, necessita de reparos nas escadas de madeira e nos guarda-corpos ao longo do caminho. Necessário implantar novas placas informativas e interpretativas.

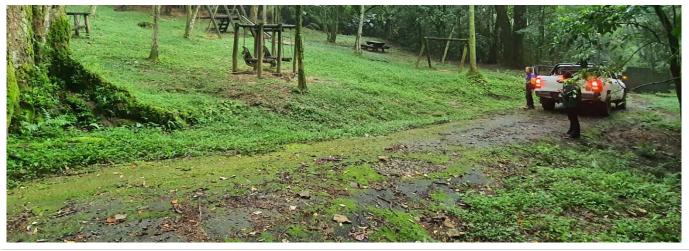
Necessário realizar a manutenção e limpeza, já que pavimentação está com musgo, dificultando passagem de veículos. Entrada do bosque com um certo grau de dificuldade para acessar. Deverá Implantar placas informativas e interpretativas.

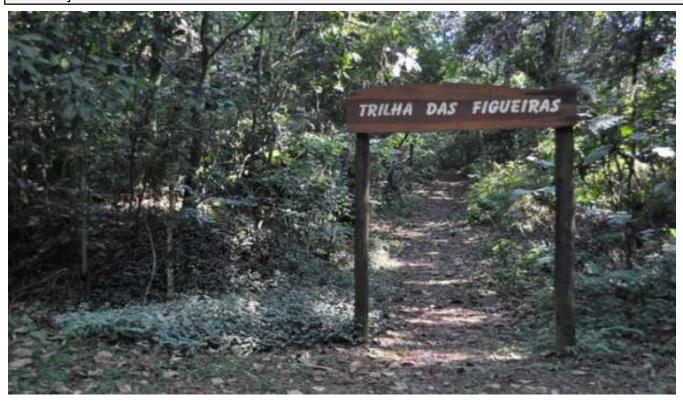
Nome: 22- Trilha das Figueiras
Uso atual: 1.380,00 m - Caminhadas

Necessário realizar a manutenção. Deverá Implantar placas informativas e interpretativas.

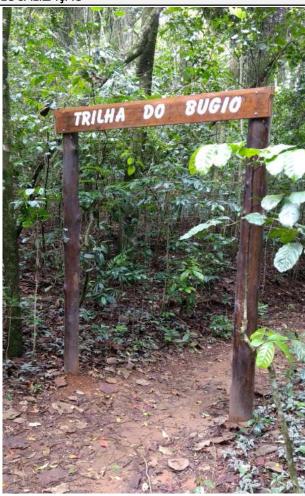
Elemento:	Área externa
Parque Núcleo	Cantareira Núcleo Pedra Grande
Nome:	24 - Trilha do Bugio
Uso atual:	666,00 m - Caminhadas, fiscalização

Necessário realizar a manutenção. Deverá Implantar placas informativas e interpretativas.
